Sodium Sulfate Corrosion of Silicon Carbide Fiber-Reinforced
Calcium Aluminosilicate Glass-Ceramic Matrix Composites

Submitted in partial fulfillment
of the requirements for the degree of

MASTERS OF SCIENCE IN MECHANICAL ENGINEERING
from the

NAVAL POSTGRADUATE SCHOOL

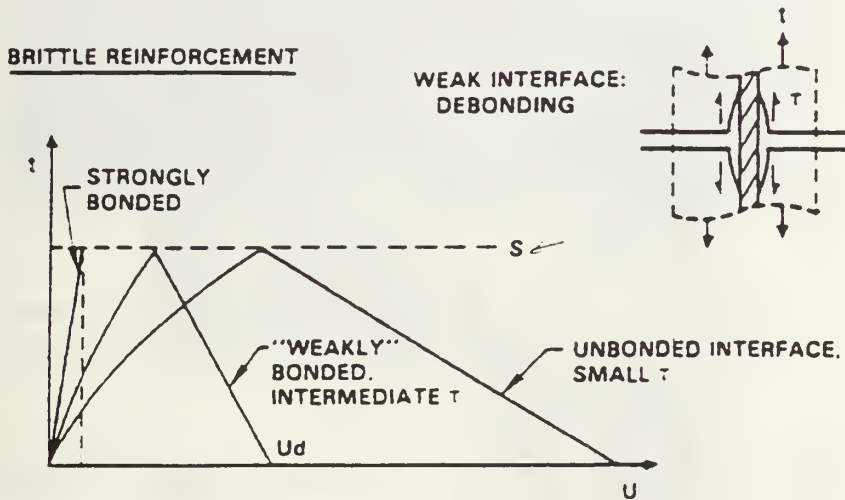
Figure 6. A Schematic Illustrating Various Trends in Crack Openings With Stress [Ref. 10: pg. 2570]

prior to failure. The effect of fiber bridging on the brittle reinforcement of the matrix is represented in Figure 6.

The weak interface requires a much larger crack for fiber failure to occur than in the strong interface thus reducing the brittle effect of the composite. The unbonded interface is not considered. [Ref. 10: pg. 2570] Figure 7 shows crack blunting by SiC fibers.

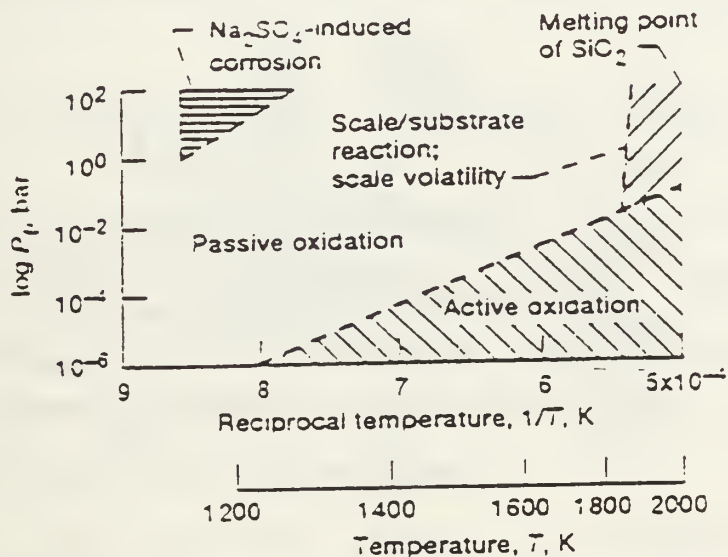
Figure 9. Types of Corrosive Attack and Degradation as an Approximate Function of Reciprocal Temperature [Ref. 12: pg. 6]

The salt is deposited on engine components and hot corrosion occurs in a limited temperature range as displayed in Figure 9.

Sodium sulfate acts as a corrosive agent between its melting point 884 °C and up to its dew point 1000 °C (at one atm), which is dependent upon the partial pressure as

The SiC/CAS composite is being considered for application in the divergent flaps and seals in the gas turbine convergent/divergent nozzle exhaust system. This engine component experiences temperatures between 650-1100 °C, which is well within the corrosive region depicted in Figure 9 and

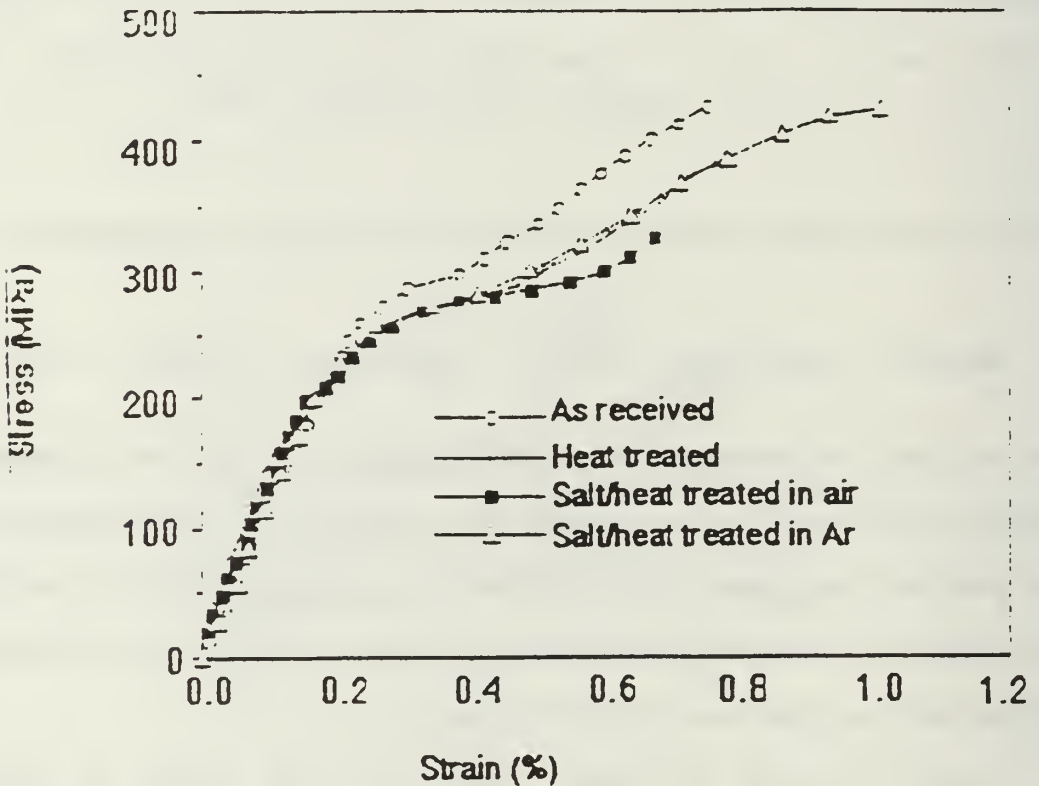
Figure 11. Stress Strain Curves of SiC/CAS Tensile Specimens that were Exposed in Varying Environments [Ref. 15: pg. 11]

Previous work by Wang, Kowalik, and Sands on sodium sulfate corrosion of SiC/CAS has indicated an approximate 25% reduction in tensile strengths of samples coated with salt and heat treated to 900 °C in air. Figure 11 provides an experimental stress-strain plot for as received, heat treated, salt/heat treated in air and salt/heat treated in argon. Fiber degradation was substantial in the sample coated/heat treated in air hence a loss of tensile strength however a loss

of less than 10% of it's tensile strength was observed in the sample coated and treated in argon. This indicates that the fiber degradation was less severe in the argon atmosphere. [Ref 15,pg. 11]

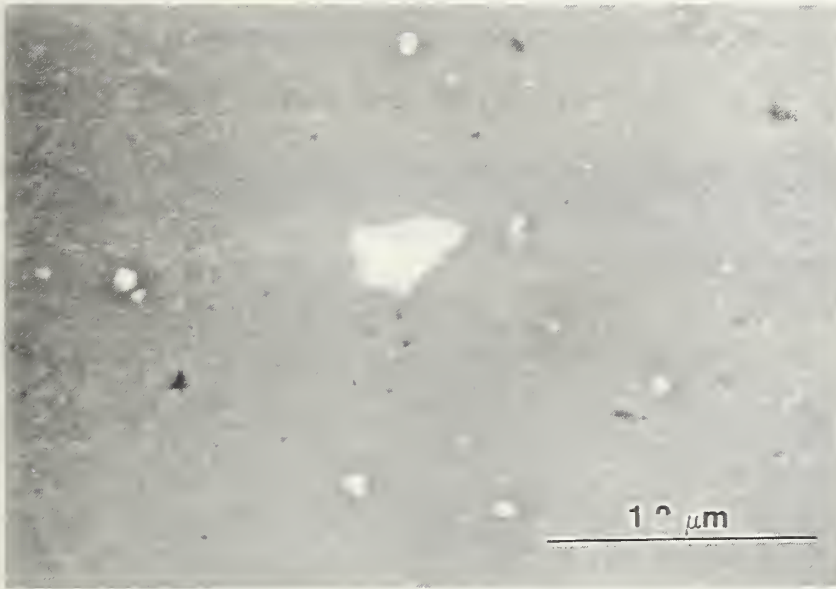
Figure 18. BSE Micrograph of Zircon Particle in As-Received Sample

Small bright particles (up to 5µm in diameter), evenly dispersed throughout the matrix, were determined to be zircon (ZrO₂·SiO₂) as verified by SEM analysis. EDX spectrum analysis (Figure 17) yielded a 1:1 zirconium oxide to silicon oxide atomic percent ratio. Small particles (< 1 µm), believed to be zircon (or zirconia), were also present on grain boundaries. Grain sizes were observed to be as large as 6 µm in diameter. A micrograph of a large zircon particle is

presented in Figure 18. X-ray elemental mapping (Figure 19) indicates the zircon particle contains concentrated regions of Zr and Si.
